River Contaminates Town's Water Supply

When State Leaves It to Beavers

ULTRAVIOLET DISINFECTION

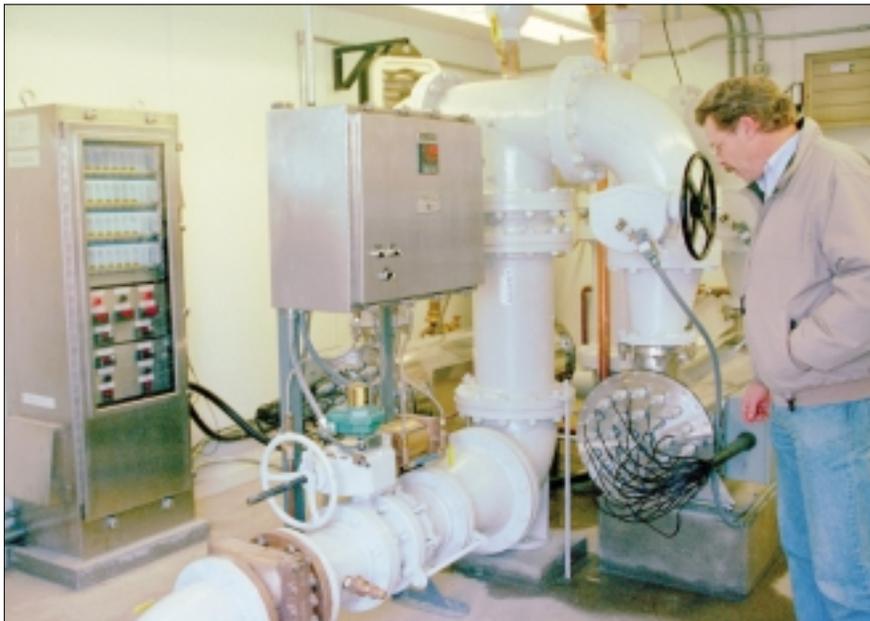
After attending a presentation on ultraviolet disinfection, Louis Manring, superintendent, Department of Public Works, Sterling, Mass., examined it as a means for permanent and primary disinfection at the Sterling water treatment plant.

With funding in place and the pilot-ing successfully completed, the engineers worked closely with DEP to design the system and construction of the UV Treatment Plant was begun in February 2001. The UV system provided by Severn Trent Services included a programmable logic controller (PLC) design that allows water department employees to control and monitor the wells, pumps, storage tanks and UV disinfection system remotely from a personal computer in their office several miles away from the well fields, or from a laptop computer through a dial-up telephone connection.
